Evaluation of magnetic resonance imaging issues of titanium and stainless steel brackets

Linetskiy, Igor ; Starčuková, Jana ; Hubáľková, Hana ; Starčuk, Jr, Zenon ; Özcan, Mutlu

Journal Article

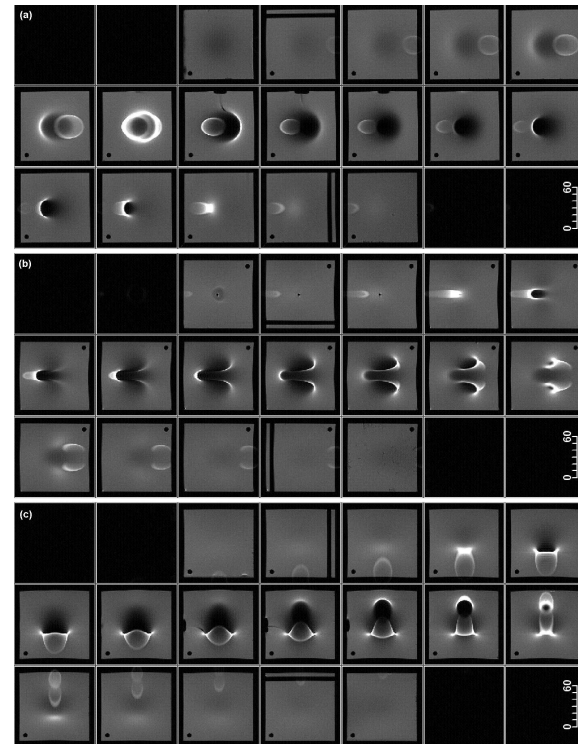
Fig. 1 SE artefacts with a single Gemini bracket the bracket size as in Table 1. Acquisition parameters: SE, 21 slices, thickness 3 mm, gaps between slices 3 mm, FOV 120 mm × 120 mm, matrix 256 mm × 256 mm, TR = 3000 ms, TE = 15 ms, refocusing pulse flip angle 180°, bandwidth 125 Hz/pixel. (a) Transverse slices with LR readout. For the other gradient assignment, the artefacts were found nearly identical with axes exchanged. (b) Coronal slices with LR readout. The same artefact shapes appeared in sagittal slices with AP readout. (c) Sagittal slices with IS readout. The same artefacts were found in coronal slices with IS readout.

For each single bracket, the maximal distance between the bracket boundary and the fringe of the artefact, as well as the maximal artefact area are listed in Table 4. In MRI imaging using the GE sequence, which is more prone to metal artefacts than the SE sequence, the linear size (*d*) of the distortion caused by SS bracket was by about an order of magnitude larger than that found with the Ti bracket (in sagittal images > 50 mm versus 4.9 mm, in coronal images > 50 mm versus 4.7 mm and in transversal images > 50 mm versus 4.8 mm). Furthermore, the artefacts caused by a single SS bracket often extended over the whole observed volume, i.e., over all slices and the whole ROI (Figs. 1, 2), while distortions caused by the titanium bracket were just local (Figs. 3, 4). The dependence of artefact size on echo time in GE images was

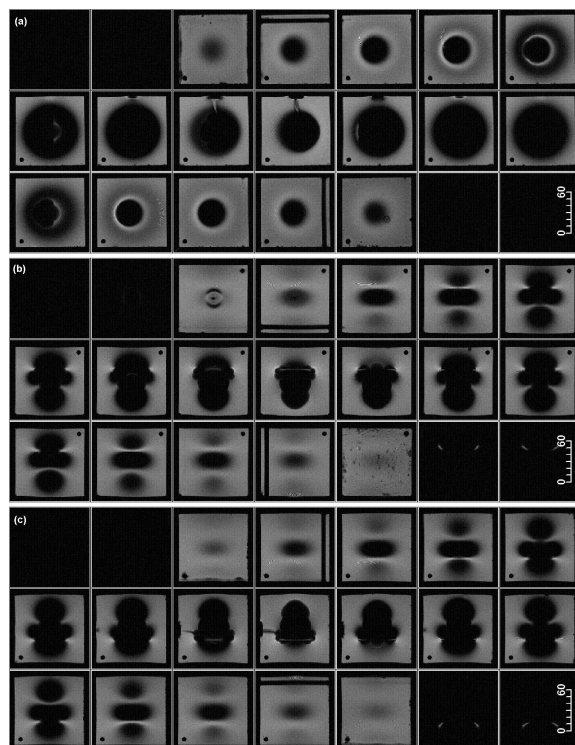
Fig. 2 GE artefacts with a single Gemini bracket the bracket size as in Table 1. Acquisition parameters: GE, 21 slices, thickness 3 mm, gaps between slices 3 mm, FOV 120 mm \times 120 mm, matrix 256 mm \times 256 mm, TR = 200 ms, TE = 10 ms, flip angle 35°, bandwidth 125 Hz/pixel. (a) Transverse slices with LR readout. (b) Coronal slices with IS readout. (c) Sagittal slices with IS readout. No effect of gradient assignment change was observed.

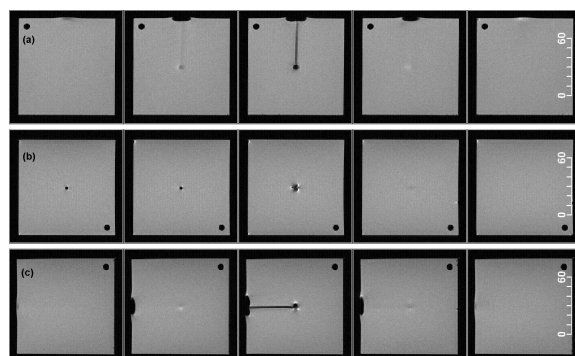
Fig. 3 SE artefacts with a single equilibrium ti bracket. The same measurement parameters as in Fig. 1. (a) Transverse slices. (b) Coronal slices. (c) Sagittal slices. Change of gradient assignment had no effect.

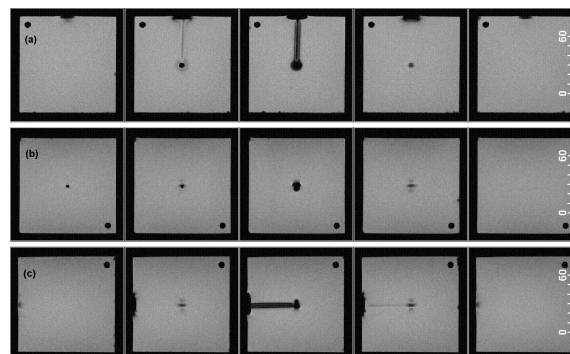
Fig. 4 GE artefacts with a single equilibrium ti bracket. The same measurement parameters as in Fig. 2. (a) Transverse slices. (b) Coronal slices. (c) Sagittal slices. Change of gradient assignment had no effect.

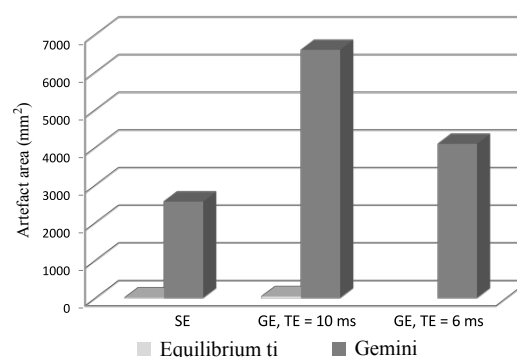
Fig. 5 Comparison of artefact areas in sagittal images for a single equilibrium ti and Gemini bracket. The column height in the graph represented the artefact area found in the sagittal images for both SE and GE images. As the artefact of GE image (TE = 10 ms) for Gemini bracket extended outside of the phantom volume, the artefact area outside of the box was estimated and overall artefact area evaluated to 6600 mm². GE images for TE = 6 ms were not acquired for equilibrium ti.

also observed (Fig. 5). The whole set of the SS brackets mounted on a jaw model precluded MR measurement by rendering the system incapable of adjusting the resonance frequency. Artefacts caused by titanium brackets mounted on a jaw model were considered diagnostically acceptable according to visual scale (Table 3), because the distortions were just local. They are displayed in Fig. 6.

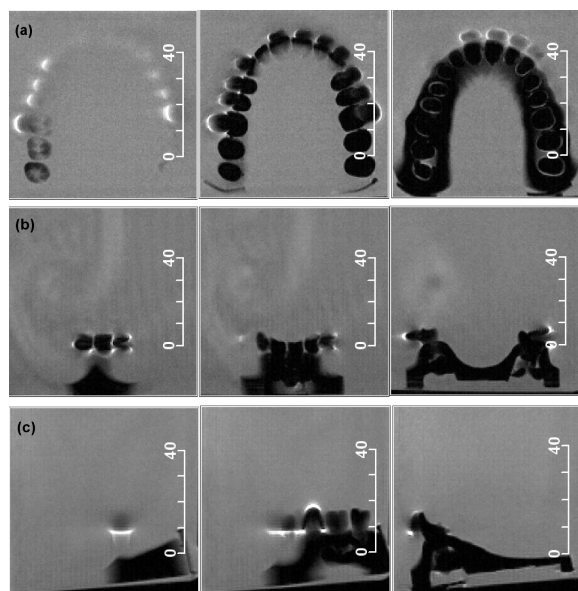
Fig. 6 SE artefacts with equilibrium ti bracket sets mounted on a jaw model. (a) Transverse slices, LR readout, IS position 42 mm, 48 mm, and 54 mm from the central slice. (b) Coronal slices, LR readout, AP position 24 mm, 20 mm, and 4 mm from the central slice. (c) Sagittal slices, IS readout, LR position 36 mm, 30 mm, and 0 mm from the central slice. Maxillary right lateral incisor bracket was missing to allow the comparison.
